# Evidence of Performance

### Test Report

No. 16-000936-PR02

| <b>Product</b> | <b>Low-E Vacuum insulating glass unit</b> |

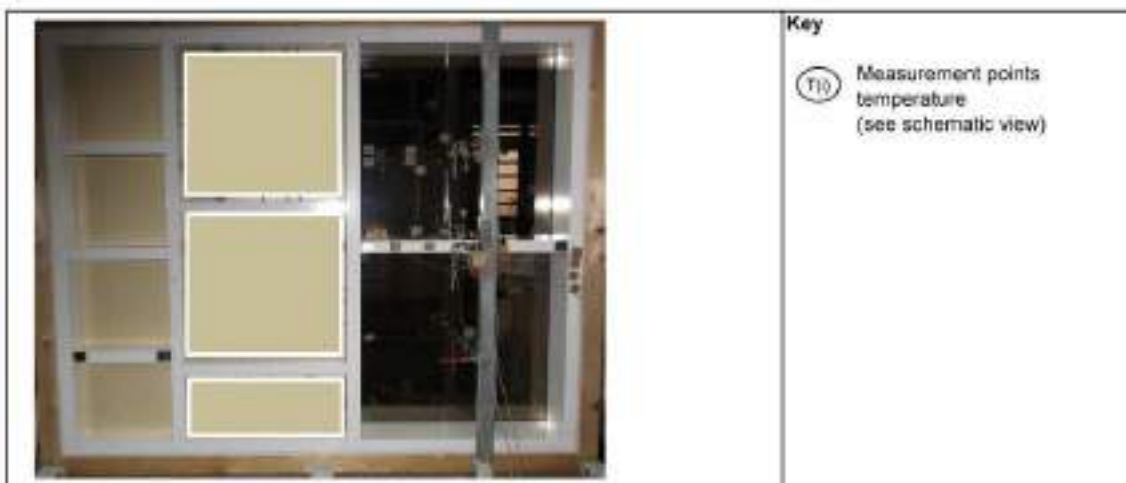
#### 1: VIG 1000 mm x 1000 mm

- 1: Temperature in center of VIG, on distance piece
- 2: Temperature in center of VIG, between distance pieces
- 3: Temperature in center of VIG, between distance pieces
- 4: Temperature at left edge of VIG, near to distance piece
- 5: Temperature at left edge of VIG, between distance pieces
- 6: Temperature at bottom edge of VIG, near to distance piece
- 7: Temperature at bottom edge of VIG, between distance pieces
- 8: Temperature at corner of VIG, near to distance piece
- 9: Temperature at corner of VIG
- 10: Temperature in center of transom
- 12: Temperature in center of VIG, between distance piece
- 13: Temperature at top edge of VIG, between distance pieces
- 14: Temperature at left edge of VIG, between distance piece
